NASA/TM-2017-43; 7: 6

Emergency Locator Transmitter Survivability and Reliability Study

February 2017

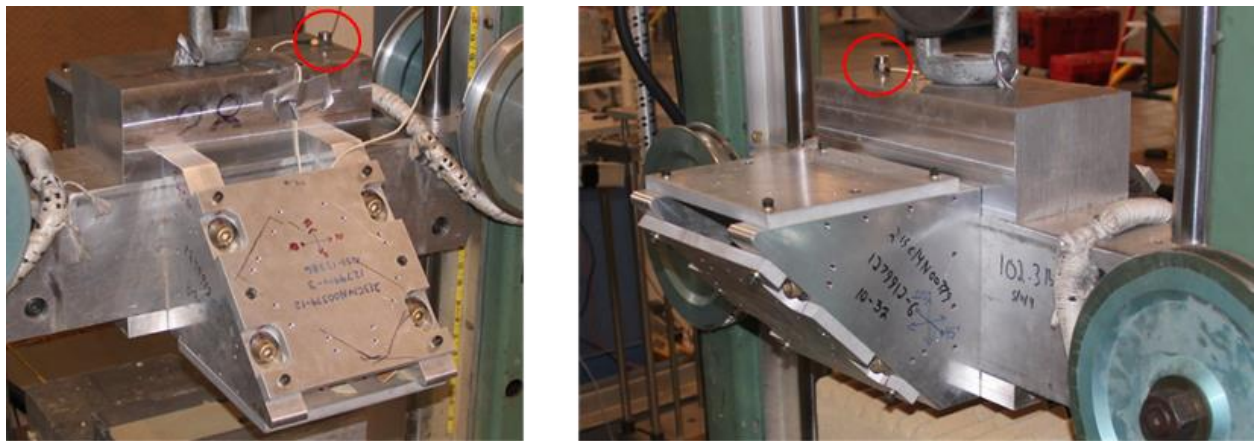
Figure 2. Crash Safety Test Fixtures (accelerometer highlighted)

In the final case of interest, another system that utilized a TSO C-126b compliant mounting system was observed to demonstrate the phenomenon of beacon ejection in a repeatable fashion. The sensitive orientation for this system was when mounted to one of the triangular, side-facing mounting planes shown in Figure 2, with the beacon primary sensing axis clocked 45° with respect to the drop direction. Rather than a metallic strap and clasp system or hook-and-loop fastener, this mounting system utilized a synthetic fabric strap and plastic buckle. As such, this finding is a motivating example of the need for improvements to the existing performance-based requirements, rather than elimination of a single design characteristic based on real world outcomes.

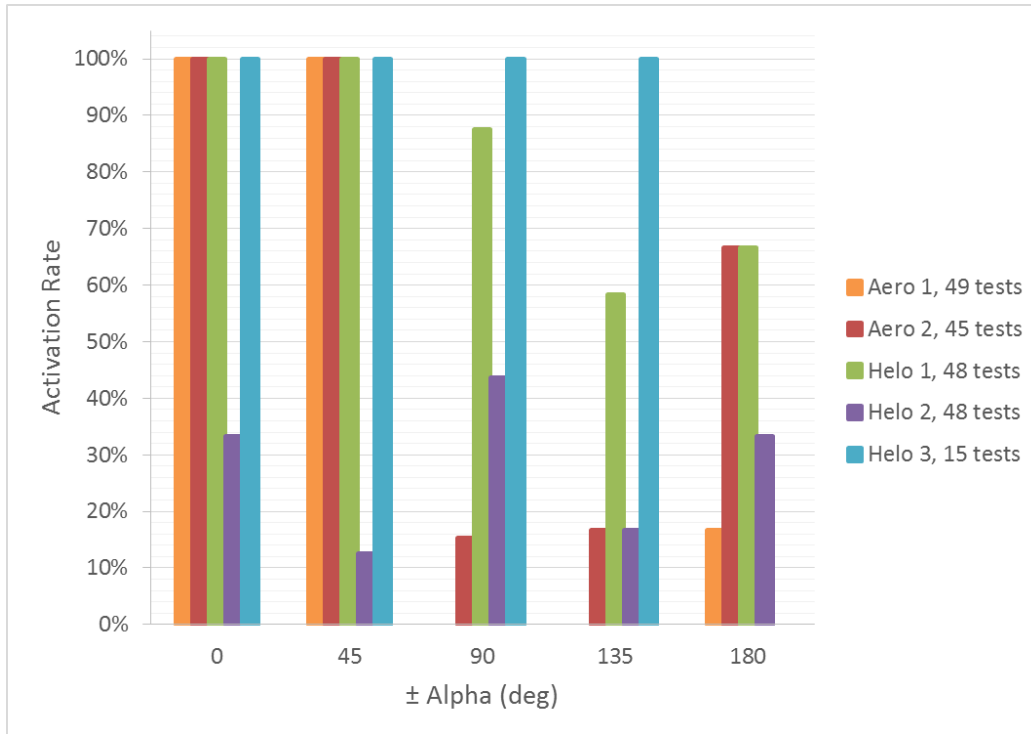
Figure 4. Crash Safety Test - Automatic Activation Rate as a Function of Beacon Orientation

Figure 4 summarizes the activation rate for the 5 ELTs tested as a function of the crash sensor orientation with respect to the gravity vector. The term “Aero”, or “airplane”, is used to refer to an ELT with a single-axis crash sensor and “Helo”, or “helicopter”, is used to denote a six-axis crash sensor. “Helo 3” incorporated a solid-state crash sensor, whereas all others employed mechanical crash sensors, or g-switches.

As shown in Figure 4, all but one of the units tested activated automatically 100% of the time when the crash sensor was oriented within $\pm 45^\circ$ of the gravity vector. Outside of that range, performance decreased significantly for the mechanical g-switch equipped units. The only unit to activate automatically in response to every test was “Helo 3”, which used a solid-state, six-axis crash sensor. It was not possible to test this unit in the + or - 180° orientations due to interference issues with the test facility.

Functional performance results indicate the need for increased rigor in qualifying ELT systems for automatic activation and corroborate reports of inactivated ELTs involved in aviation accidents. A simple approach to addressing this issue would be to require successful automatic activation of ELTs equipped with crash sensors when conducting crash safety qualification testing.

It is recommended that crash safety test procedures be updated to include additional tests that impart simultaneous multi-axis loading, a pair of pulseforms within the range of “severe but survivable” crashes and demonstration of successful automatic activation of AF systems during environmental exposure. Improvements to performance of beacon mounting systems, antenna connection survivability and crash sensor performance are expected as a result.

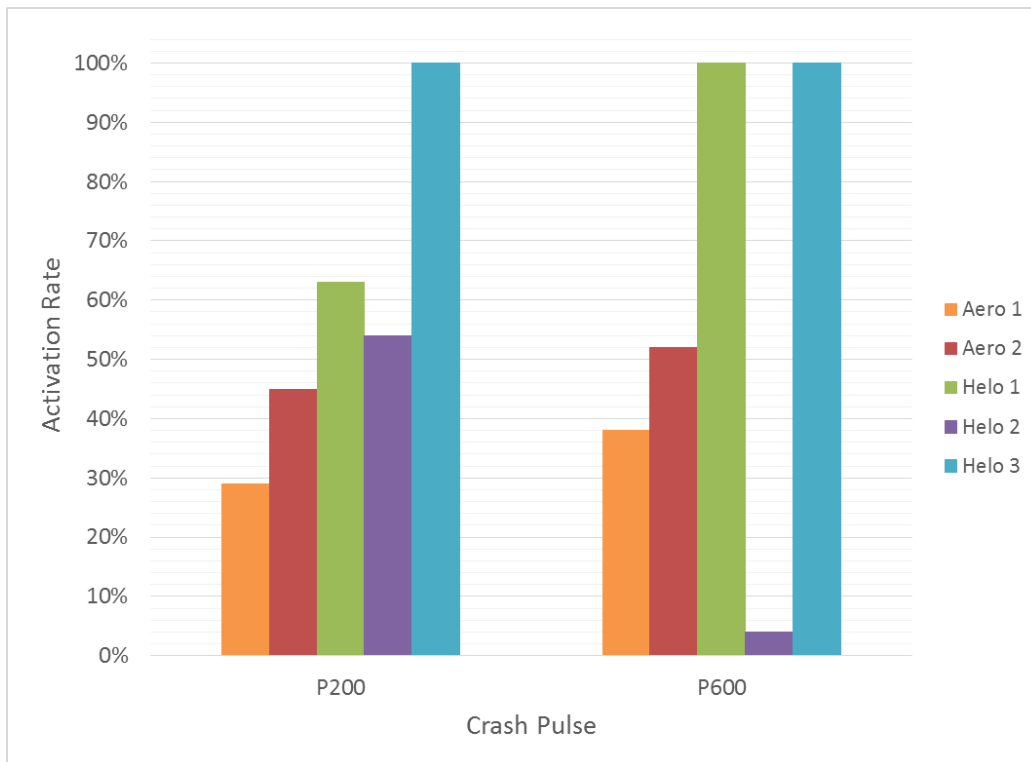
Figure 5. Crash Safety Test - Automatic Activation Rate as a Function of Pulseform

Figure 5 displays the activation rate for each ELT as a function of crash pulse. As discussed above, P200 was the lower-g, longer duration pulse with respect to P600. As can be seen, the activation rate is higher in response to the higher-g, P600 pulse, for 3 of the 5 units tested. 1 of the units performed best when subject to the P200 pulse and, again, the unit with the solid-state crash sensor activated in all cases, regardless of pulseform.

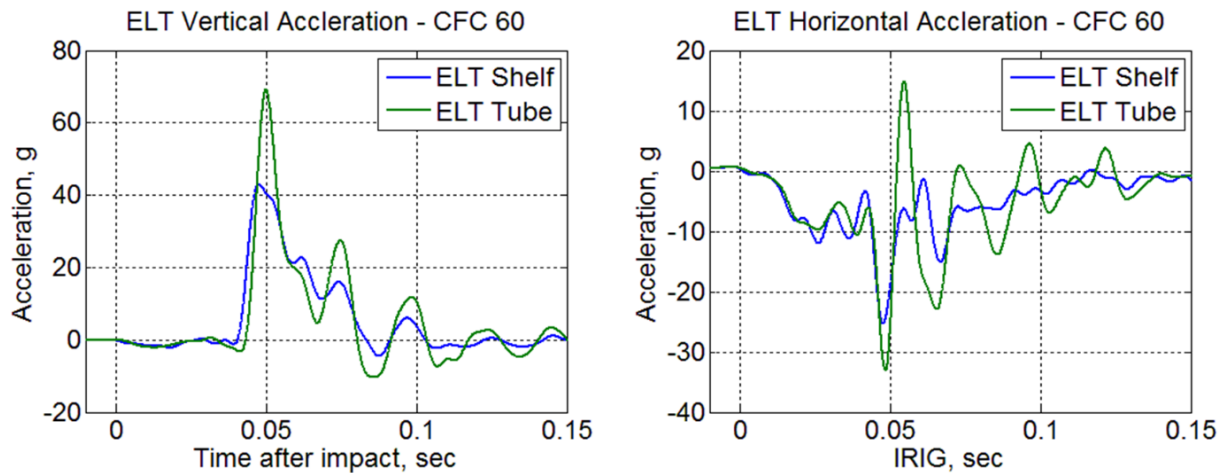
Figure 18. ELT Acceleration Time-History Onboard TRACT 2

The peak acceleration values differ between the shelf and tube responses, as the tube maximum was approximately 69-g, while the shelf maximum was approximately 43-g in the vertical direction. This difference is due to the flexure mode of the shelf, which amplified the acceleration peak. The ELT shelf accelerometer was mounted on the aft-right corner of the shelf, near the cockpit vertical wall, adjacent to the shelf-to-wall attachments. This placement was a more rigid configuration with minimal shelf deflection.

Comparing the measured accelerations to Figure 7, the TRACT 2 environment should have resulted in automatic activation of each ELT, regardless of the variations in beacon orientation.

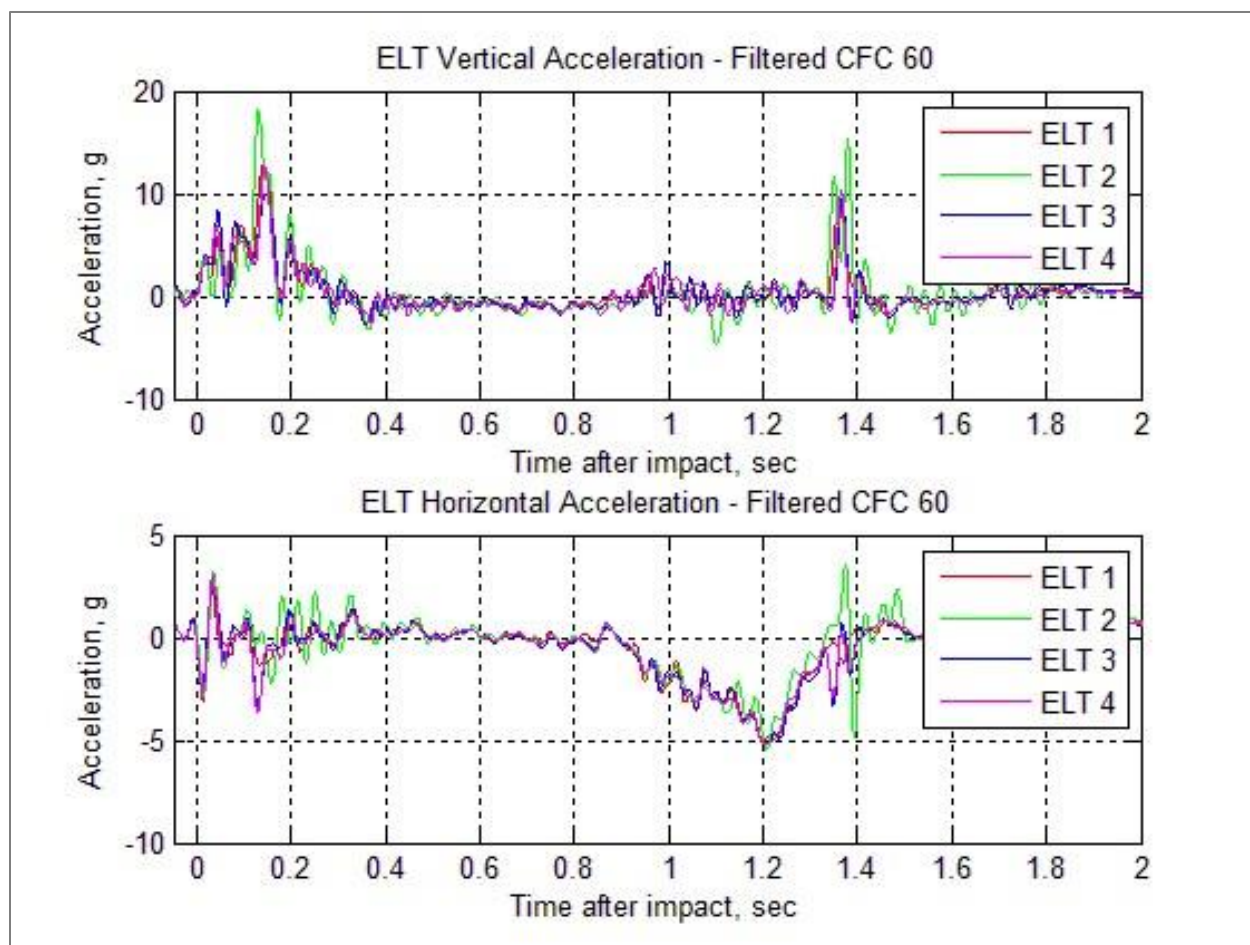
Figure 22. Beacon Accelerations - Airplane Crash Test 1

Figure 22 shows the acceleration environment experienced by each ELT beacon. Ground impact corresponds approximately from time 0- to 0.4-sec as shown in the vertical acceleration plot. Net impact corresponds approximately from time 0.9- to 1.6-sec as shown in the horizontal acceleration plot.

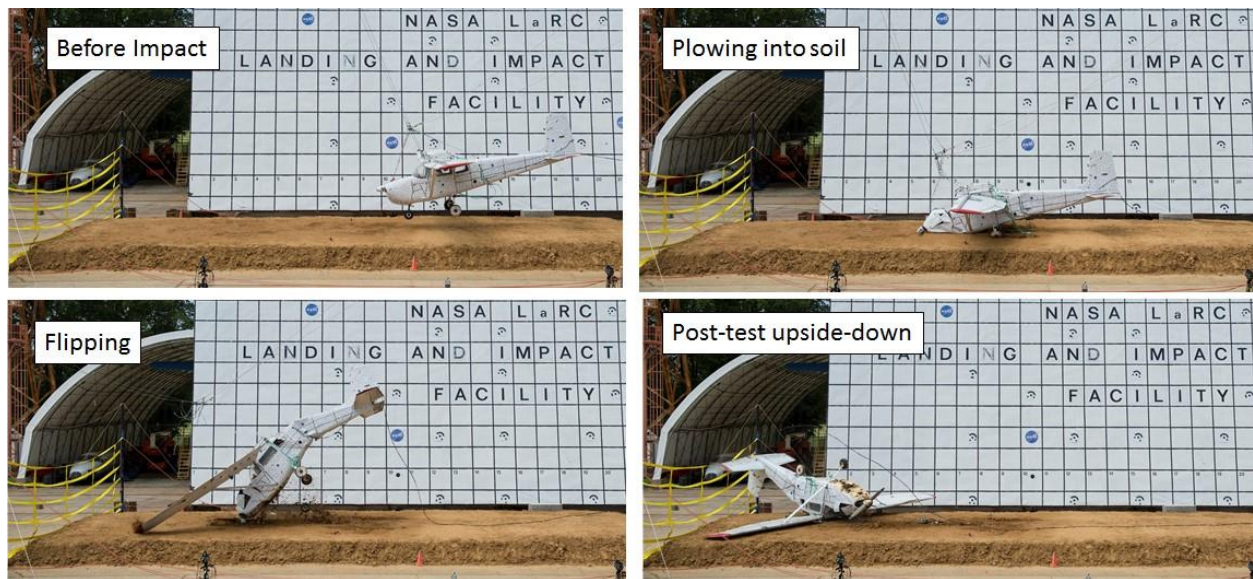
Figure 24. Impact Sequence – Airplane Crash Test 2

The second airplane crash test simulated a controlled flight into terrain scenario. The aircraft was oriented in a 12.2° nose-down configuration at impact with a flight path velocity of 74.4-ft/sec prior to impacting soil. The sequence of events are depicted in Figure 24.

This was a much more severe environment than the first airplane crash test, but ATD results confirmed that the crash event was survivable. Given the potential for severe injury, this test represented a prime scenario for SAR.

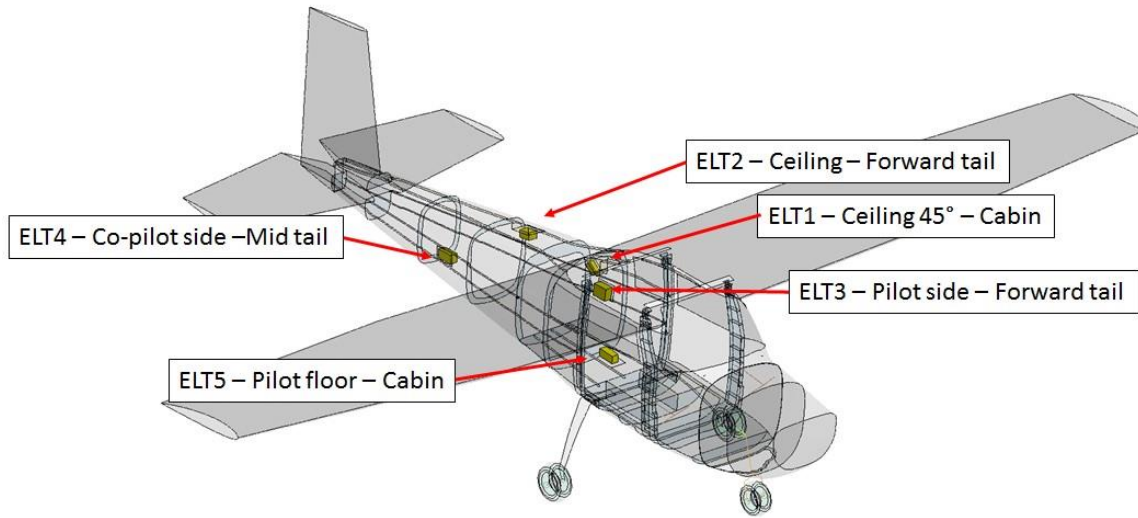
Figure 25. Beacon Layout - Airplane Crash Test 2

The layout of the 5 ELT beacons installed onboard the aircraft is depicted in Figure 25. Again, these installations represent a range of typical GA aircraft configurations. The ELT 1 beacon was installed in the typical fashion for helicopter applications when using an ELT with a single-axis crash sensor (cabin ceiling mounted at a 45° nose-down orientation). ELT 2 was a “helicopter model” containing a collection of six g-switches. These types of models are to be installed flatwise

and again, a ceiling-mounted configuration was selected aft of the ELT 1 beacon. ELTs 3-5 contained single-axis, mechanical g-switches and were located as shown.

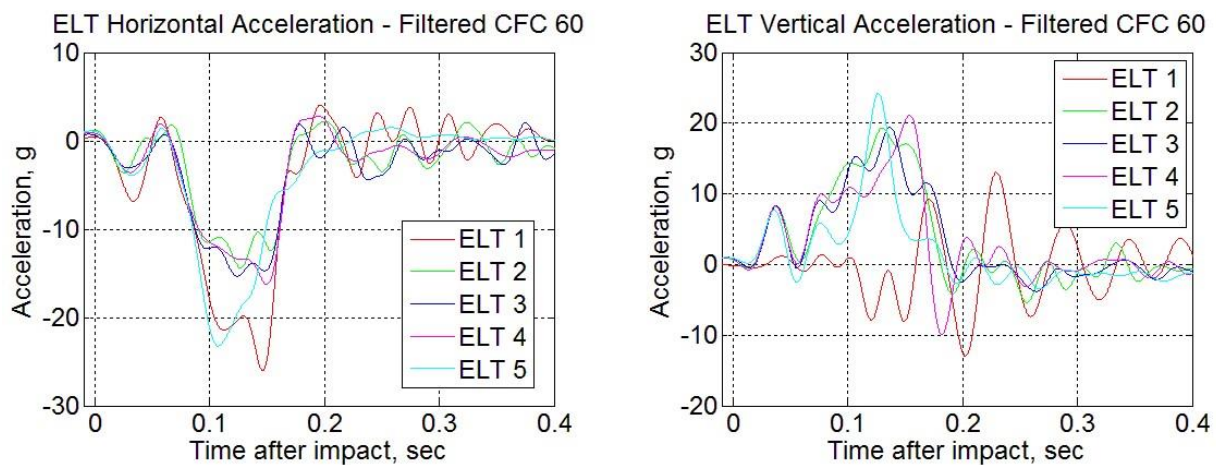
Figure 26. Beacon Accelerations - Airplane Crash Test 2

The acceleration environment experienced by each ELT beacon is shown in Figure 26. The relative amplitude and duration of loading experienced by each unit varies depending on installation location and orientation.

The largest horizontal loads were experienced by the forwardmost beacons, ELTs 1 and 5, which were installed in the cabin. In general, peak accelerations across the entire set ranged from 10- to 26-g and the pulseform can be described as trapezoidal of approximately 120-msec duration.

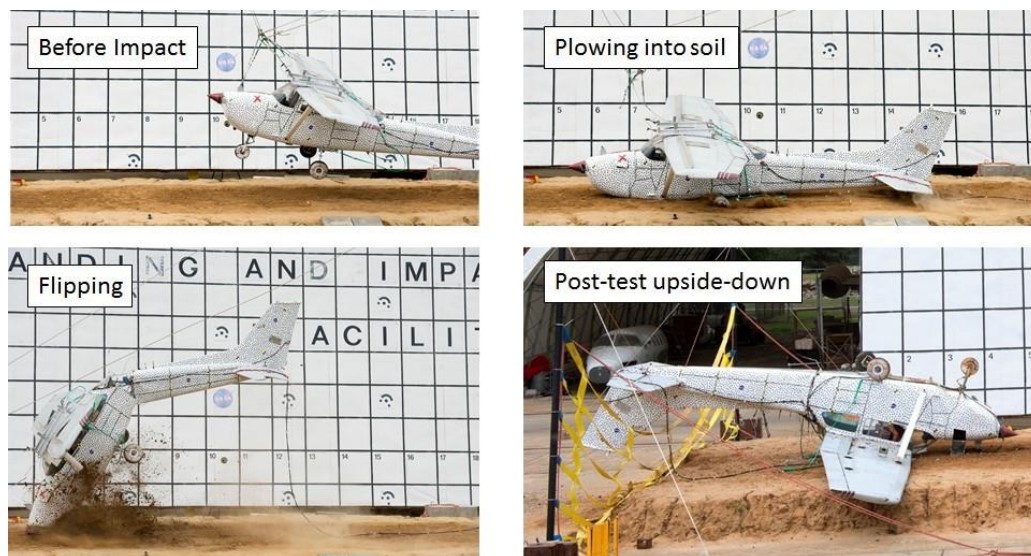
Figure 28. Impact Sequence - Airplane Crash Test 3

The third airplane crash test scenario was representative of a controlled flight into terrain, where the pilot unsuccessfully attempted to pull the aircraft up, resulting in a tail-strike condition. The airplane made initial impact with the ground at a flight path velocity of 66.1-ft/sec in a 8.0° nose-up orientation. The sequence of events are depicted in Figure 28. Similar to the second airplane crash test, ATD results confirmed that the crash event was survivable. Given the potential for severe injury, this test represented another prime scenario for SAR.

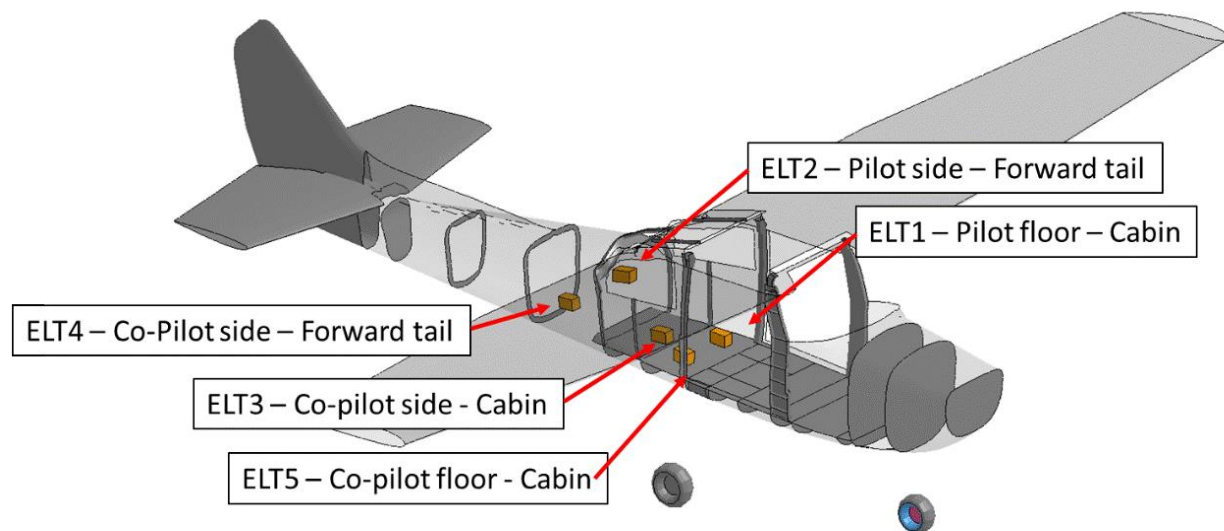
Figure 29. Beacon Layout - Airplane Crash Test 3

The relative locations of the 5 beacons are shown in Figure 29. Two “dummy” ELT system installations were included once again to provide additional insight with respect to performance impacts related to antenna cable installation techniques. The ELT 1 and 5 beacons were installed on the cabin floor, beacons 2 through 4 were mounted to the sidewall structures in the tail section.

The installation schemes were designed to replicate different techniques that are commonly employed. ELTs 1 through 4 contained single-axis, mechanical g-switches, while ELT 5 utilized a six-axis, solid-state, crash-sensor. This ELT was a new unit, but of the same make and model as the solid-state sensor equipped ELT that was included in crash safety and vibration testing.

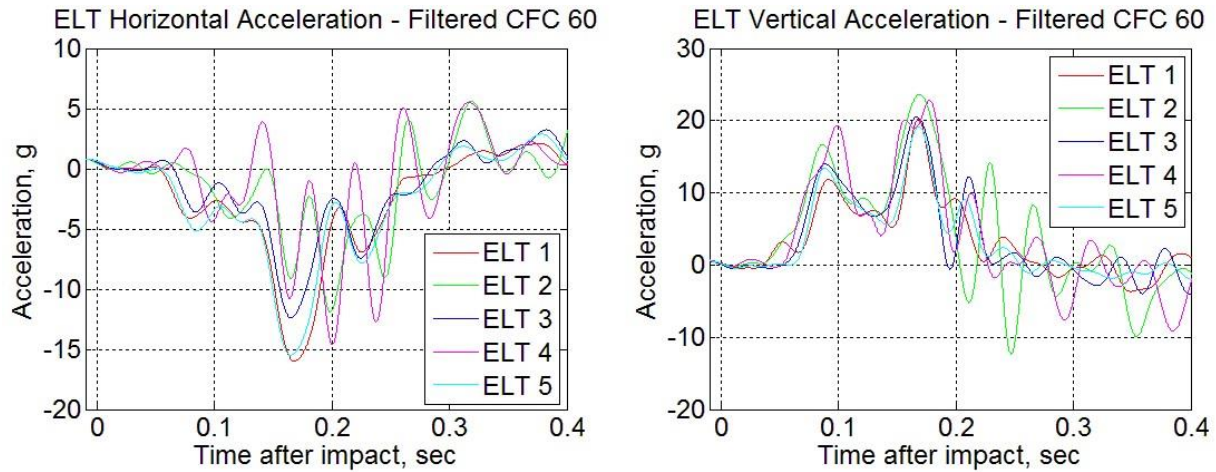
Figure 30. Beacon Accelerations - Airplane Crash Test 3

Figure 30 shows the acceleration environment measured at each beacon location during the third crash test. Variations in magnitude and dynamic content seen in the horizontal acceleration data are attributed to the large airframe deformation and structural failure of the fuselage at the cabin-tail juncture. As shown in the lower left view of Figure 28, the tail was almost completely severed during the sequence. The recorded acceleration environment at each ELT location exceeded the minimum threshold for automatic activation.
